City of Detroit
Department of Recreation Performance Audit
Exhibit 3 – River Rouge Park

Basketball

Baseball

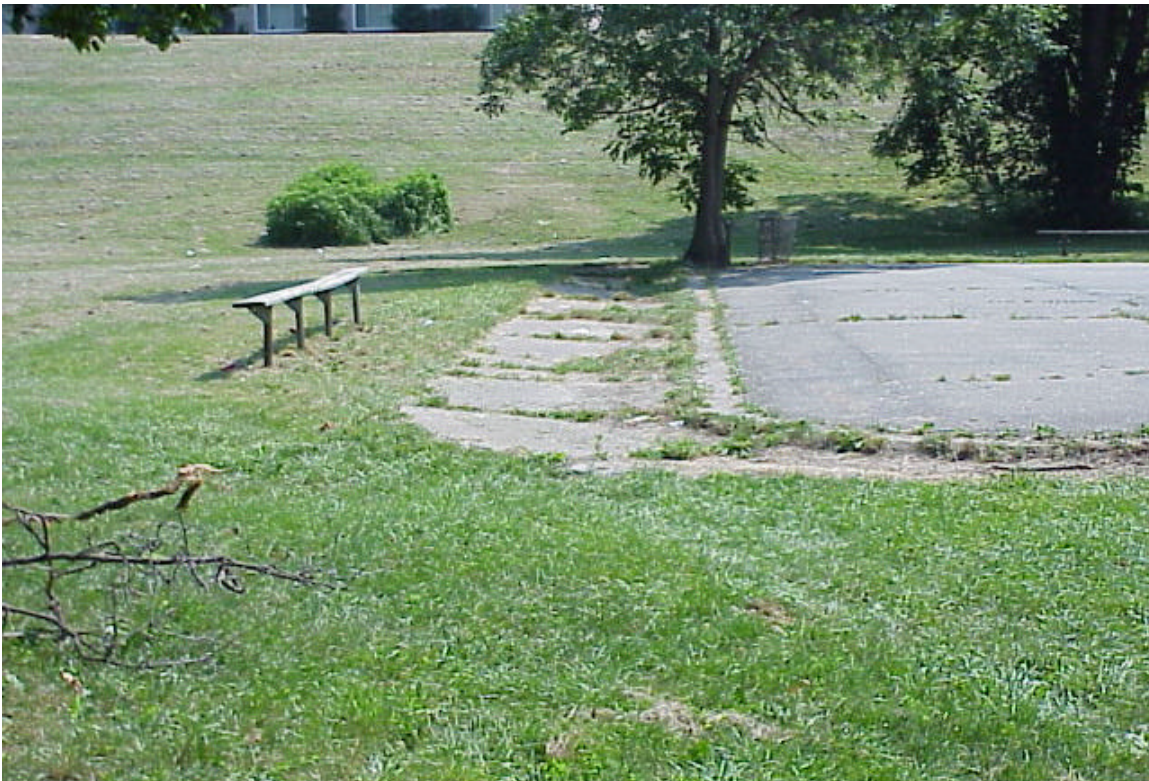
- Three courts, of which one was useable (one has a missing backboard and one was overgrown with trees).
- Cement had minor cracks with grass growing through.
- The area surrounding the courts included cracks and uneven cement, as well as a large hole by one of the benches.

These courts had a rough, uneven surface beside the courts. Surface was cracked with grass growing through.

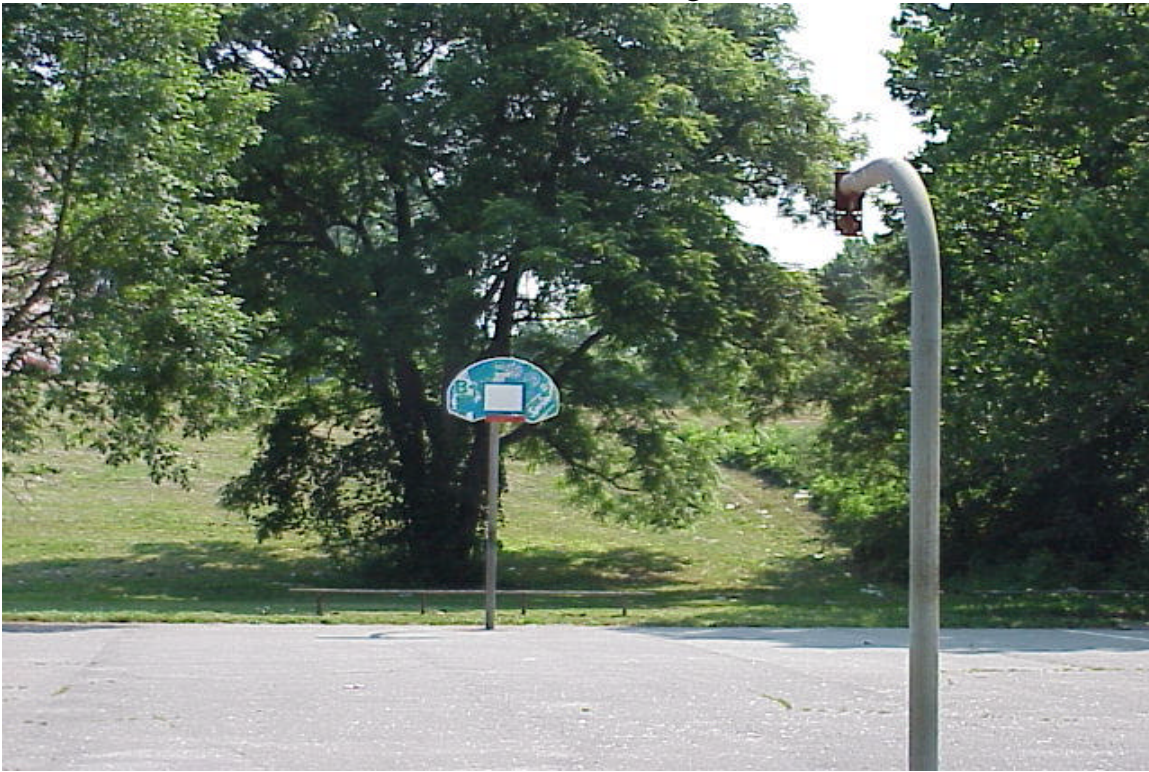
One backboard was missing.

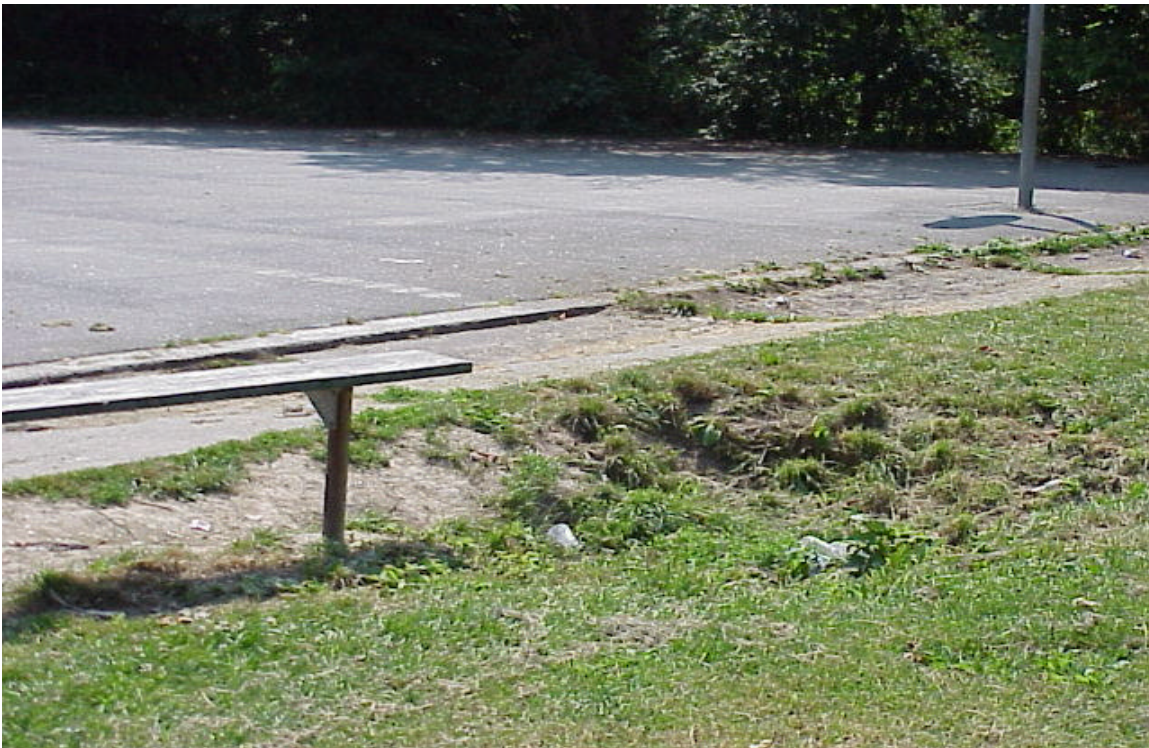
This was a large 'sink' hole next to the court benches.

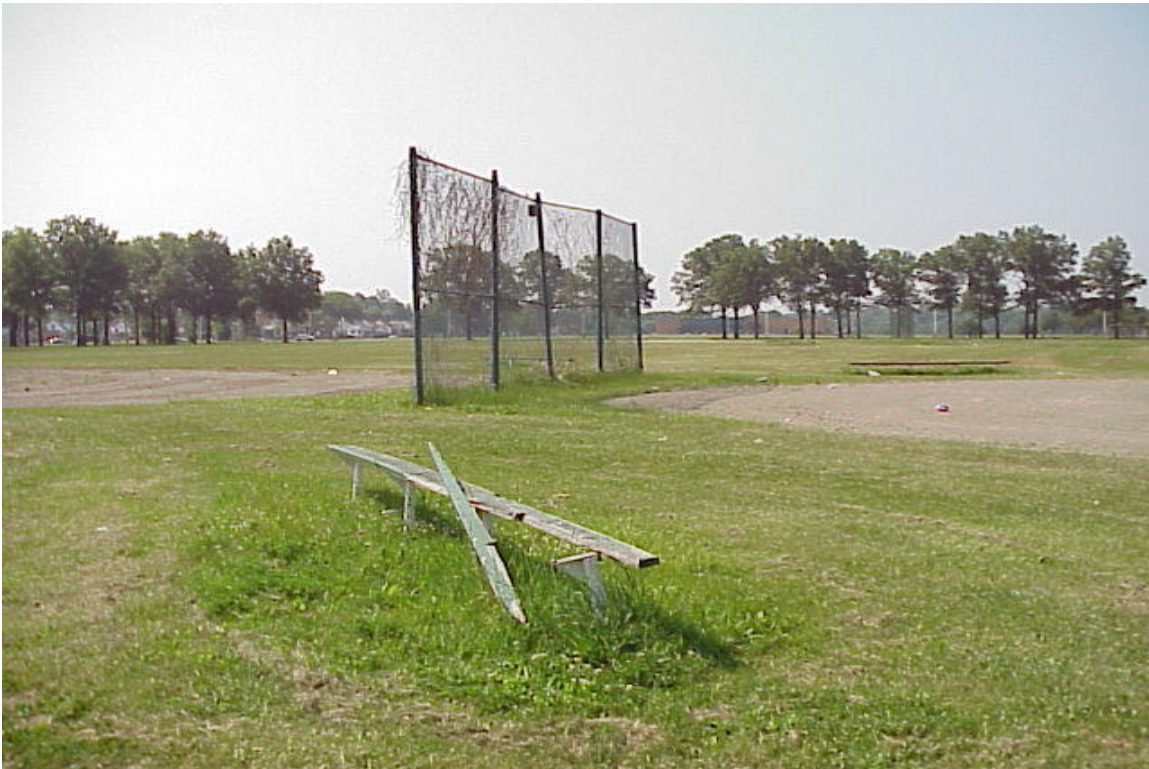
- One field of four total was unusable due to grass growing over the playing surface.
- Grass needed to be cut on other fields for effective play.
- Grass was growing on the diamonds and there was inadequate athletic mill (baseball infield surface material).
- Backstops were painted, but there was no protective fencing for the players.
- One of eight benches was broken.
- There were no scoreboards.

This baseball diamond had a broken player bench and a rundown backstop. Weeds were growing around the backstop and player benches.
